MERRIMACK RIVER BASIN
FRAMINGHAM, MASSACHUSETTS

RESERVOIR NO 2 DAM
MA 00338

PHASE I INSPECTION REPORT
NATIONAL DAM INSPECTION PROGRAM

JULY, 1981

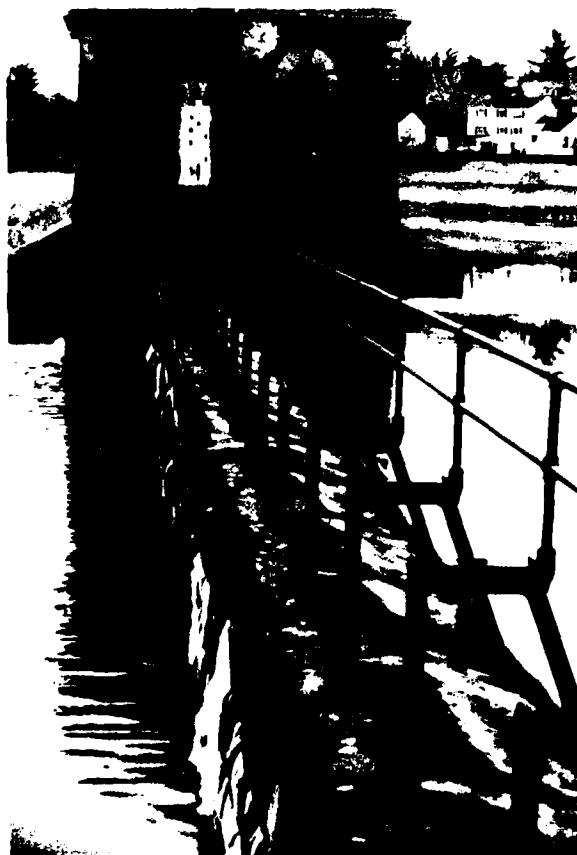
Photo No. 10 - Downstream side of granite spillway.
